Place, address or brief description of person or property to be searched  
U.S. Sugar Corporation, Bryant Village,  
located off of State Road 98, southeast of  
Canal Point, Palm Beach County, Florida as  
more particularly described in Attachments  
A and A1.

## APPLICATION AND AFFIDAVIT FOR SEARCH WARRANT

AFFIDAVIT

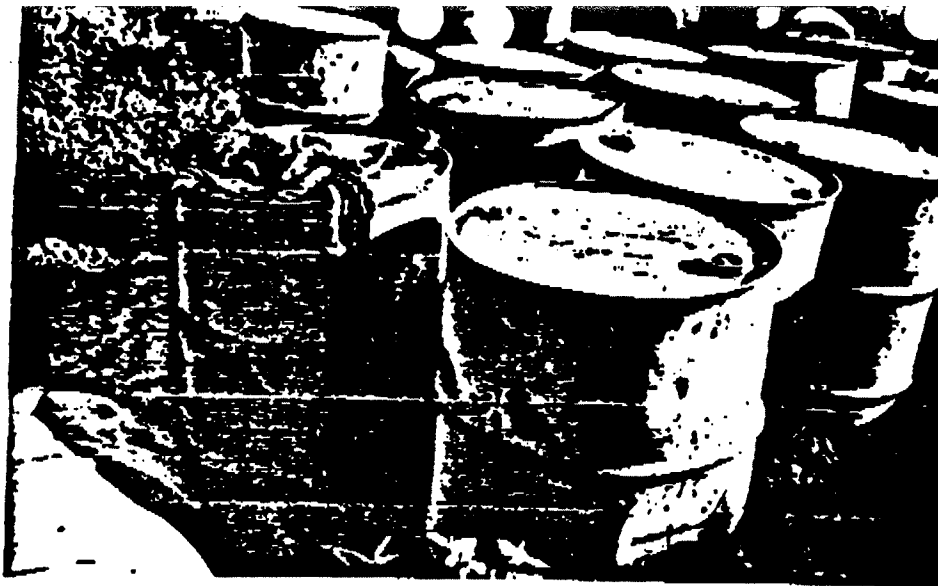
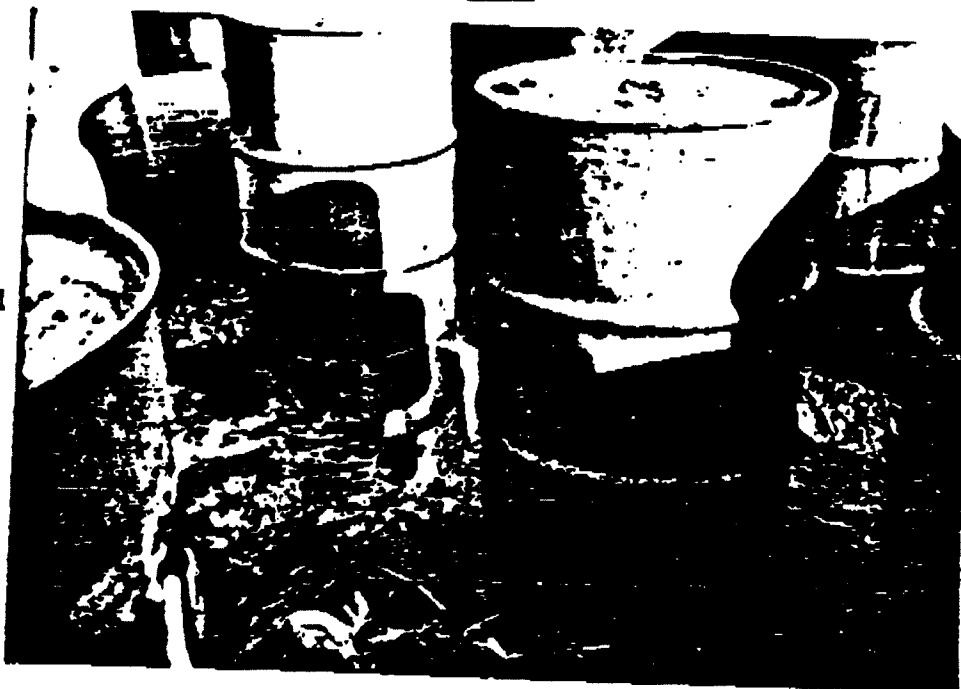
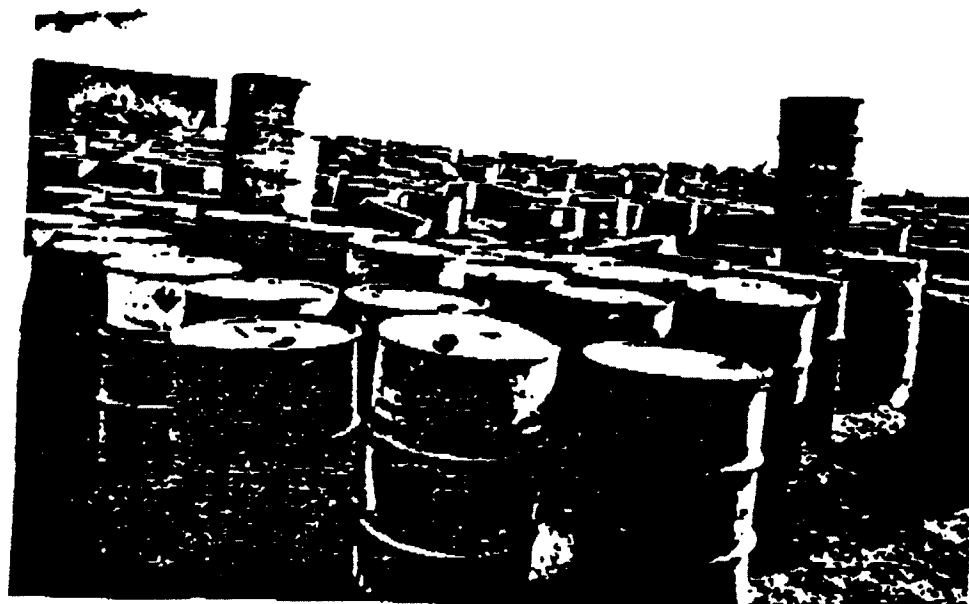
ATTACHMENT 4

Photographs of drumfield  
number 2 taken in or  
about December 1988.
