pennsylvania
DEPARTMENT OF ENVIRONMENTAL
PROTECTION

**BUREAU OF CLEAN WATER
HAMMER CREEK ADVANCE RESTORATION PLAN FIRST TRIENNIAL PROGRESS REPORT
LEBANON COUNTY
Final Public Version March 26, 2025**

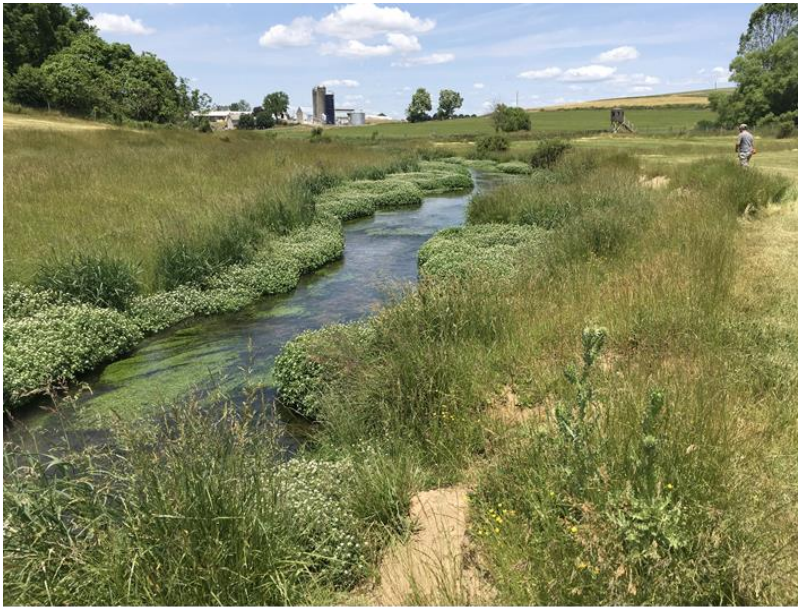
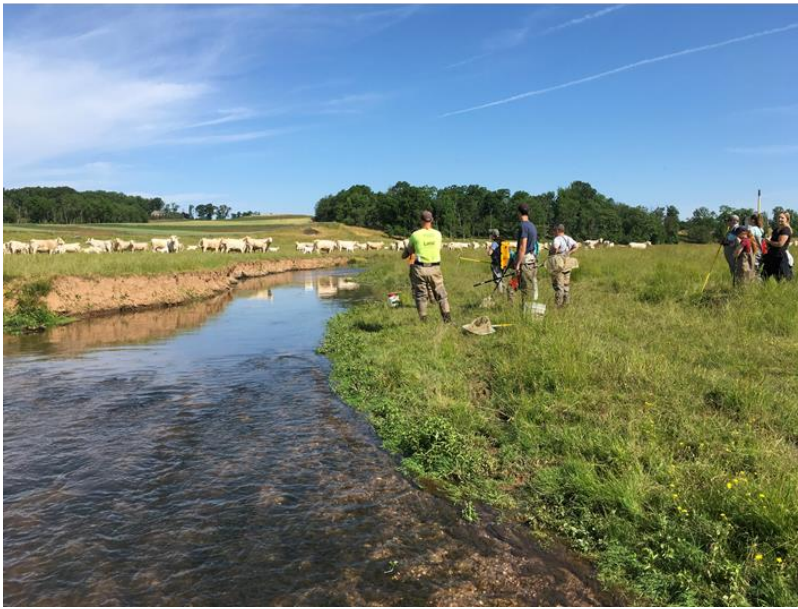
Figure 2. Photos illustrating the need for restoration at a critical site within the Hammer Creek headwaters watershed. The upper photo shows the main western tributary which appears as a nice-looking limestone stream before it enters the critical site. This water then enters a massive pasture area where hundreds of livestock have access to the stream.

Originally, it was proposed to fence livestock from the stream, establish riparian buffers, grade banks, and stabilize the stream using a natural channel design approach at this critical site. However, due to a series of historic milldams in the reach, DEP's Waterways and Wetlands and 319 sections advocated for a comprehensive floodplain wetland restoration approach focusing on legacy sediment removal, which would likely be considerably more expensive than what was originally proposed. A large Section 319 grant was awarded to design such a project, and indeed, subsequent geotechnical analysis indicates that there have been iterations of historic milldams that have caused the floodplain to be blanketed by legacy sediment.

A convincing argument can be made that legacy sediment removal would address the underlying cause of the problem, making it a better long-term solution. Plus, there may be various other benefits, such as: restoring habitat for wetland species, moderating flood pulses, and enhancing the sequestration of sediment and nutrients. However, excavating these sediments is extremely expensive, and no single funding source is likely to pay the multi-million dollar price tag. So far, the efforts to compile funding for construction, one and two million dollars per grant, have been unsuccessful. And, DEP's grant reviewers indicated that getting this quantity of funding from the 319 and Growing Greener programs is very unlikely. Thus, the future of this site is uncertain, and the risk that the project may collapse altogether may grow as time drags on. If so, there may be no riparian buffers, streambank fencing or bank stabilization work at all. Therefore, if generating the funding for such multi-million dollar projects is infeasible, the project partners must start considering a decision to revert back to plans for a more affordable, though less ecologically advantageous, restoration project.

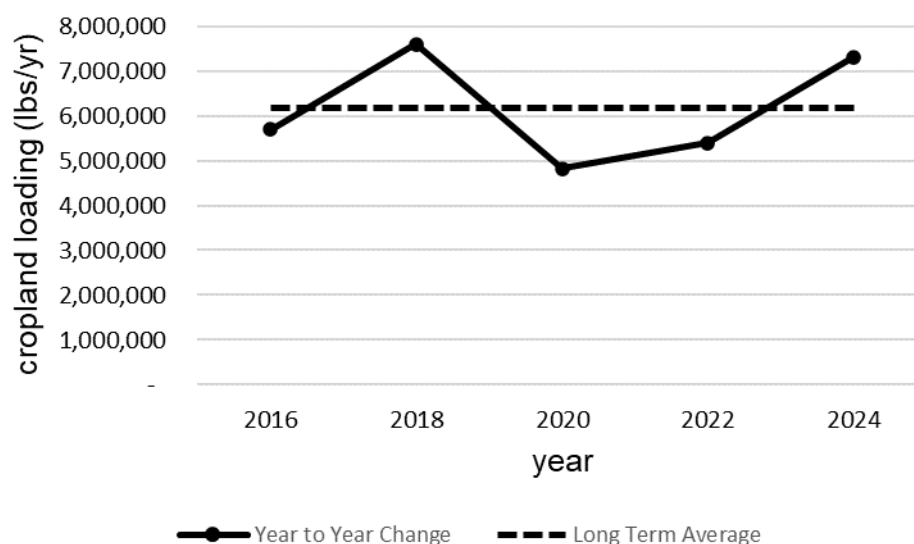
Figure 4. Estimated sediment load changes over time predicted by a changing distribution of tillage classes.

The results of this analysis are concerning, in that drastic declines in high residue crop fields since around the time the ARP was developed in 2020 may be leading to large increases in sediment loading.

At present, the factors that may be driving this concerning recent trend are not well understood. Simply attributing such drastic swings to sampling error seems unlikely. The author observed a crew collecting such data in another county, and it was noted that they possessed a great deal of agricultural expertise and receive ongoing training. And, while the time spent at any given sample point was very brief, to the extent that many sites are just observed from the vehicle, sample sizes were very large, even when just southeastern Lebanon County is considered. Plus, a similar analysis was made using even more data collected across the entire county and the results were very similar. Thus, even if there may not be high confidence in the classification of any single field, the vast sample sizes suggest that such large changes in tillage type distributions reflect reality.

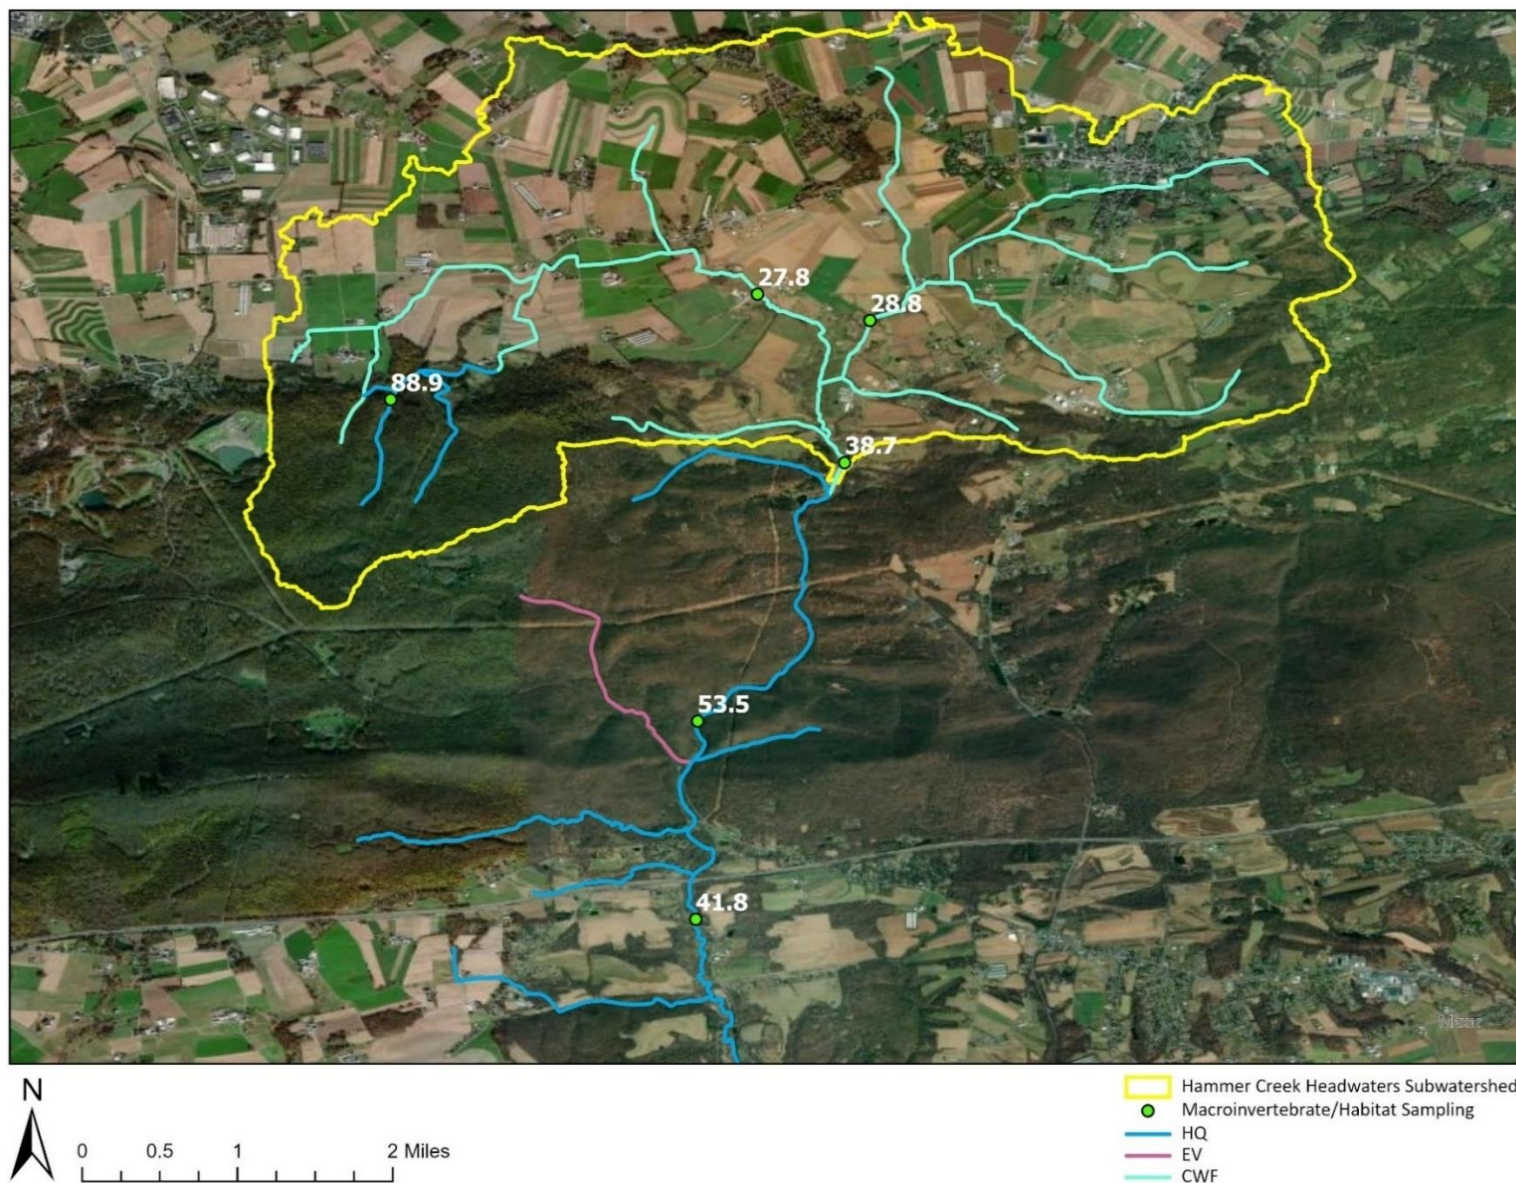
Figure 6. Benthic macroinvertebrate IBI scores for the Hammer Creek headwaters watershed and downstream mainstem. These scores are evaluated against thresholds of either 43 for stream segments designated Cold Water Fishes (CWF), or 63 for stream segments designated High Quality (HQ) (Shull 2017).

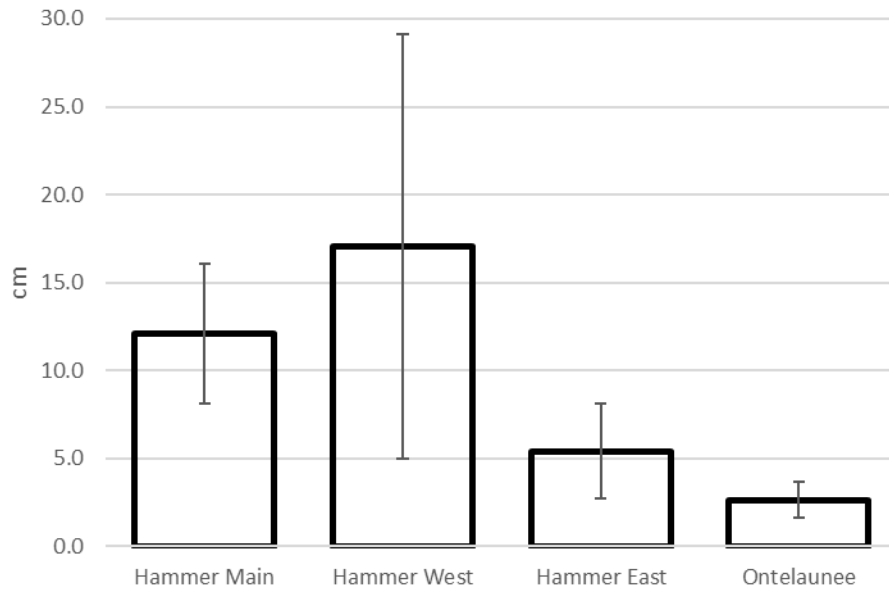
Figure 9. Mean (+/-sd) depth of fine sediment deposits in pools, as estimated by driving a probe into the streambed. Measurements were made on five consecutive, large, main channel pools within each study reach. See the original ARP for more information on methods. See Figure 8 for Hammer Creek sampling locations. “Ontelaunee” refers to the reference stream used to generate sediment load reduction goals in the original ARP.

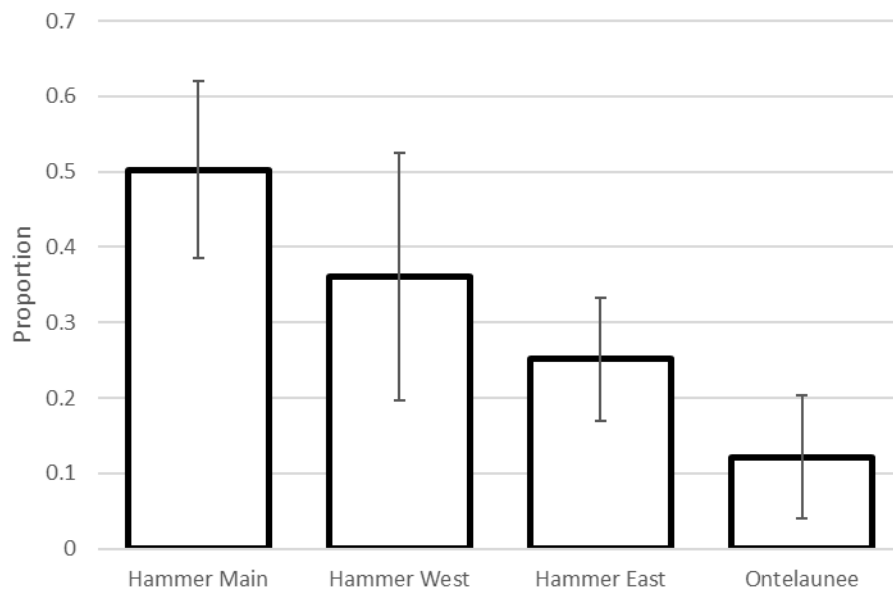
Figure 10. Mean (+/-sd) proportion of sampling points dominated by <2mm (sieve size) deposits within riffles. Measurements were made using a modified pebble count procedure in five consecutive main channel riffles within each study reach. See the original ARP for more information on methods. See Figure 8 for Hammer Creek sampling locations. Ontelaunee refers to the reference stream used to generate sediment load reduction goals in the original ARP.

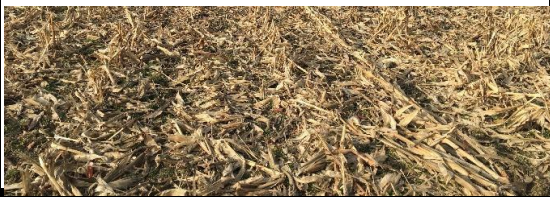
Conservation Tillage- no-till and low-till practices maintain high amounts of crop residues that shield soils from erosion. These practices also improve soil health and promote water retention, which decreases runoff. It is suggested that these practices be used wherever feasible.

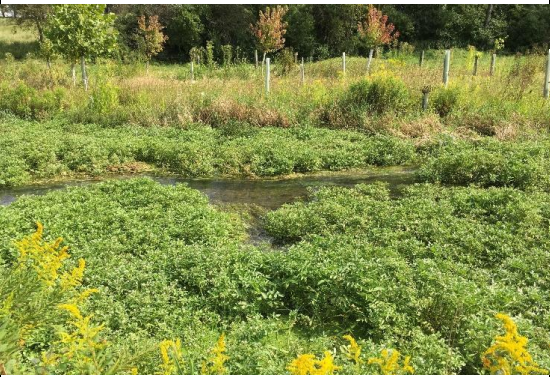
Riparian Buffers- keeping a strip of forest or other natural vegetation along the stream is perhaps the most important BMP of all. In addition to filtering pollutants such as sediment, nutrients and pesticides from runoff, riparian buffers help create good stream habitat.

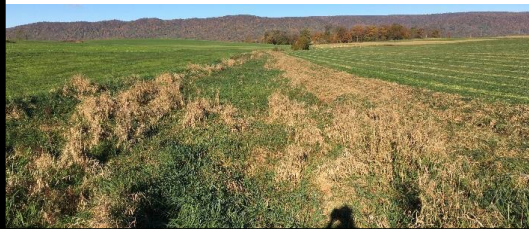
Precision Grass Filter Strips- Exposed soils travel to streams via drainage networks that are normally dry but flow after heavy rains. If unprotected, these drainage networks then discharge muddy water to streams at concentrated locations. Tall grass buffers along these drainageways may filter out most of the eroded soils before they reach the stream.

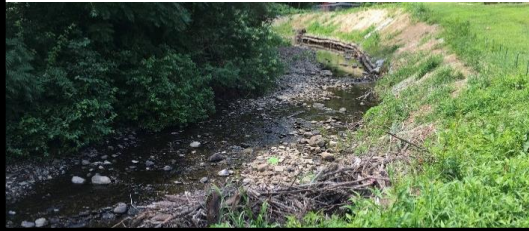
Stream Restoration-seeks to repair eroding streambanks and degraded stream habitat resulting from a legacy of stressors such as the clearing of streamside forests and wetlands, the grazing and cropping along stream banks, the construction of historic milldams, and the streamside deposition of soils.

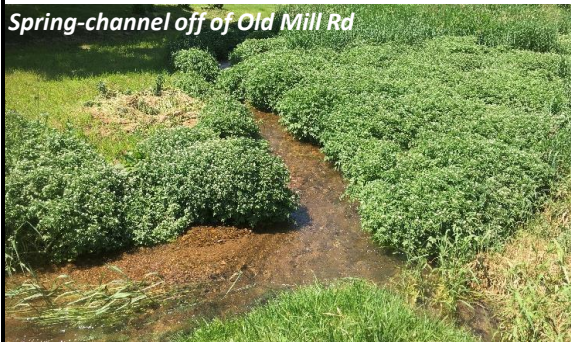
Spring-channel off of Old Mill Rd

What makes Hammer Creek special? For one, much of the valley areas of the Hammer Creek headwaters are underlain by limestone and dolomite bedrocks. These “karst” formations create features like sinkholes, caves, underground streams and **cold, clear springs**.

These springs provide the **cold water that trout need**. A second key factor is terrain. After the valley tributaries converge, Hammer Creek turns south and cuts through the Furnace Hills. These forested hills make for a swifter, shadier stream, thus providing **wilder habitat where trout could thrive**.

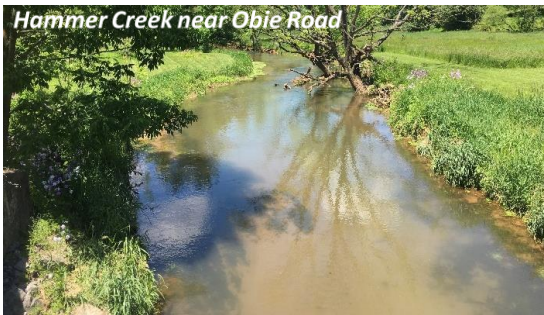
Hammer Creek near Obie Road

The good news is that Hammer Creek still harbors a limited wild trout population. The bad news is that some areas are so severely degraded by siltation that the water is murky and streambed is blanketed with thick layers of mud and sand, as in the above photo.
