Montana TMDL Stream Summaries

National Training Workshop on Water Quality Data, Assessment, & Plans

Christina Staten, Montana DEQ TMDL Section Supervisor

Madison Stream Summaries 2020

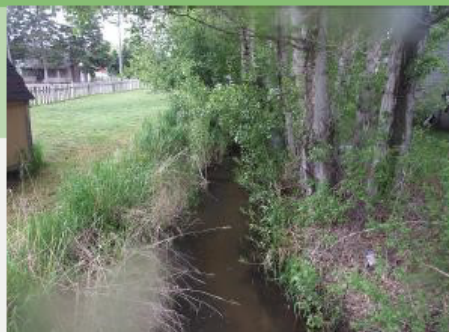
An Inadequate streamside buffer between a lawn and Moore Creek

Livestock access to the stream should be limited where possible, in conjunction with improved riparian grazing management practices. Restoration opportunities exist for many small "ranchettes" near the town of Ennis, as well as for small confined feeding operations adjacent to the stream. Directly within the town of Ennis, lawn encroachment (reduced riparian buffer widths) should be discouraged and revegetation opportunities exist for these locations. Additionally, road crossings just upstream of Frieler Creek were noted during DEQ field work as needing improvements.

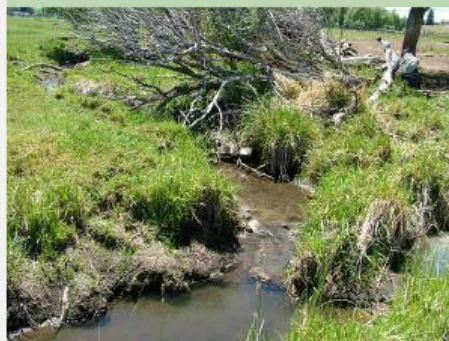
Unhealthy streamside vegetation and trampled streambanks resulting from livestock access to Moore Creek

Riparian grazing is the main contributor of excess fine sediment reaching Moore Creek, with urban encroachment (reduced riparian buffer widths and lack of native riparian vegetation) also affecting the stream where it flows through the town of Ennis. Irrigation diversions and loss of riparian habitat from irrigated cropland are directly influencing elevated stream temperatures in Moore Creek. Residential development around the town of Ennis is also contributing to temperature problems through the replacement of native, woody riparian vegetation with grass lawns that do not provide shade to the stream. In the upper portions of Moore Creek, riparian grazing is diminishing shade-providing riparian vegetation.

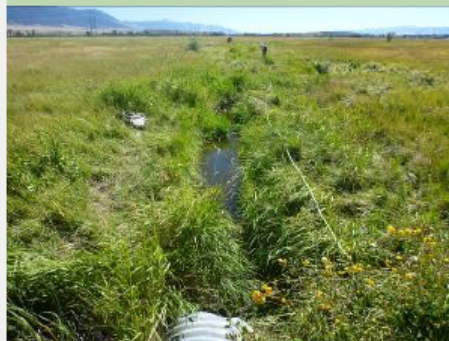
Lack of shading streamside vegetation resulting from livestock grazing along Moore Creek
