### CATEGORY 4C: PROCESSES AND EXAMPLES OF SUCCESFUL IMPLEMENTATION IN MONTANA

**Blake Towarnicki** *Water Quality Monitoring Specialist* Monitoring and Assessment Section

Kristy Fortman Physical Scientist Watershed Section

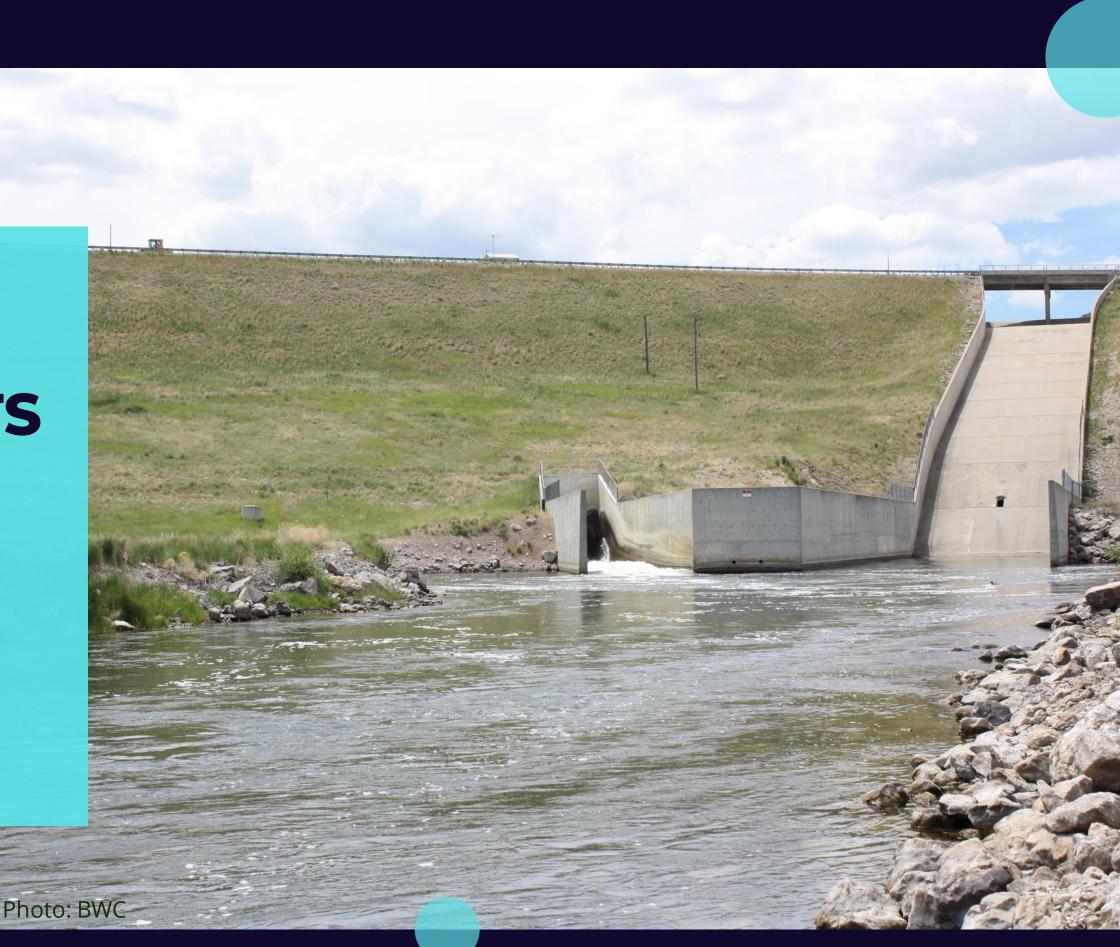
Example: Beaverhead Sediment TMDL
Pollutant Impairment: Sediment
Associated 4Cs: Low flow, streamside vegetative cover,
physical substrate
Recommendation: Dam operations
Time flushing flow to move sediment on the Beaverhead

River, near Dillon MT

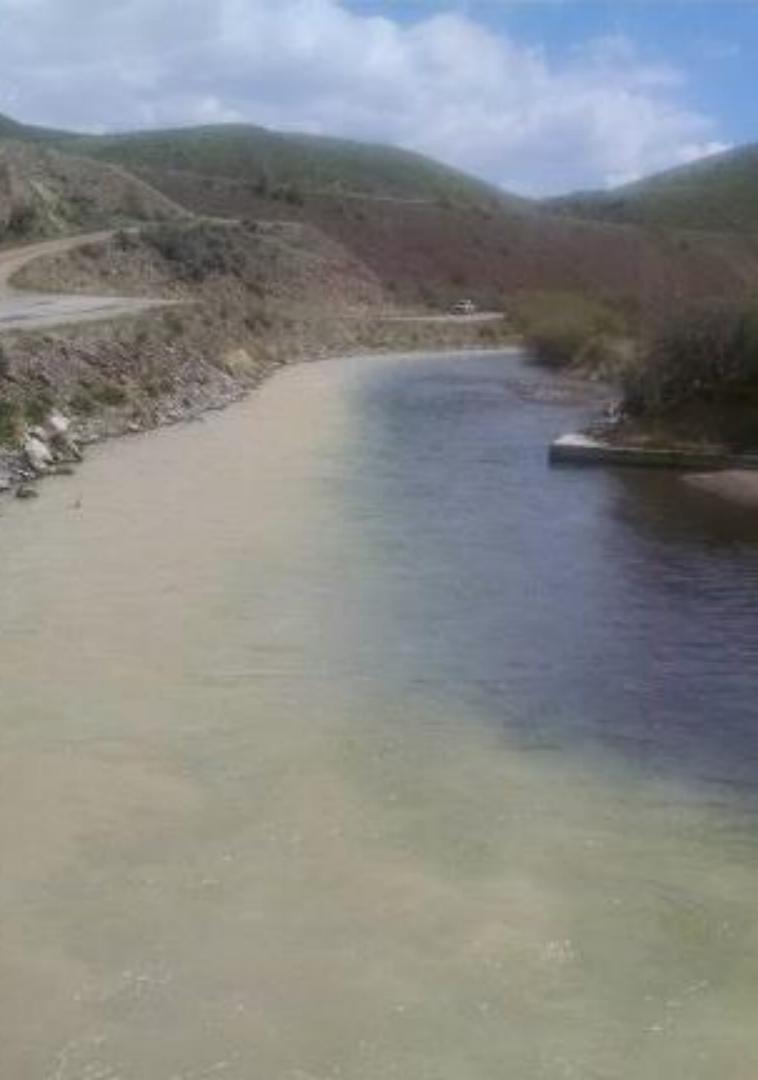
### DAM OPERATIONS

In certain years, limited releases in spring have resulted in large depositions of fine sediment in the upper segment of the Beaverhead River

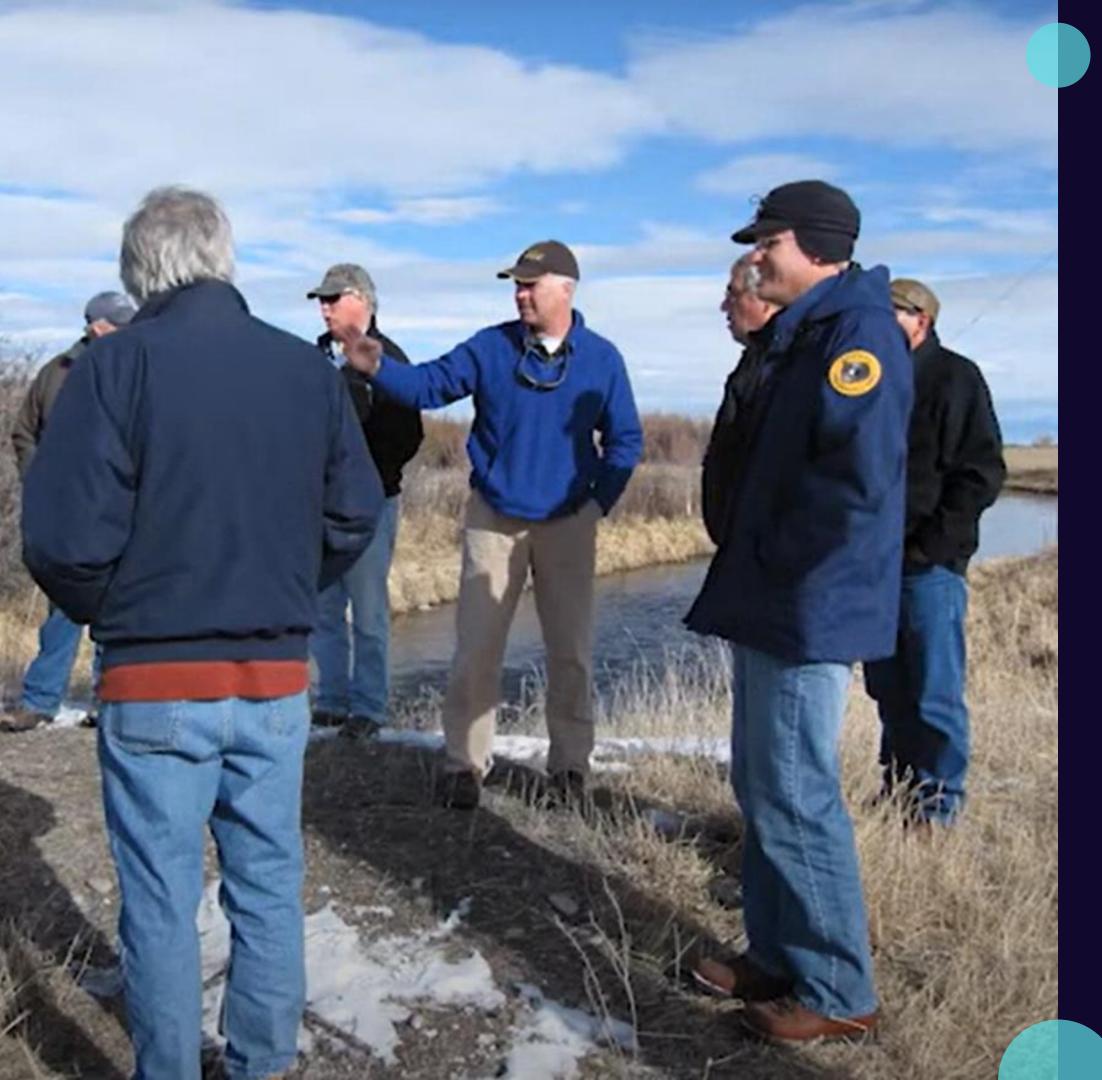
### DAM OPERATIONS

Reservoir releases From Clark Canyon Dam not timed to correlate with tributary sediment discharges into the Beaverhead River

Flushing flow study and MOU for Clark Canyon Creek and the Beaverhead River

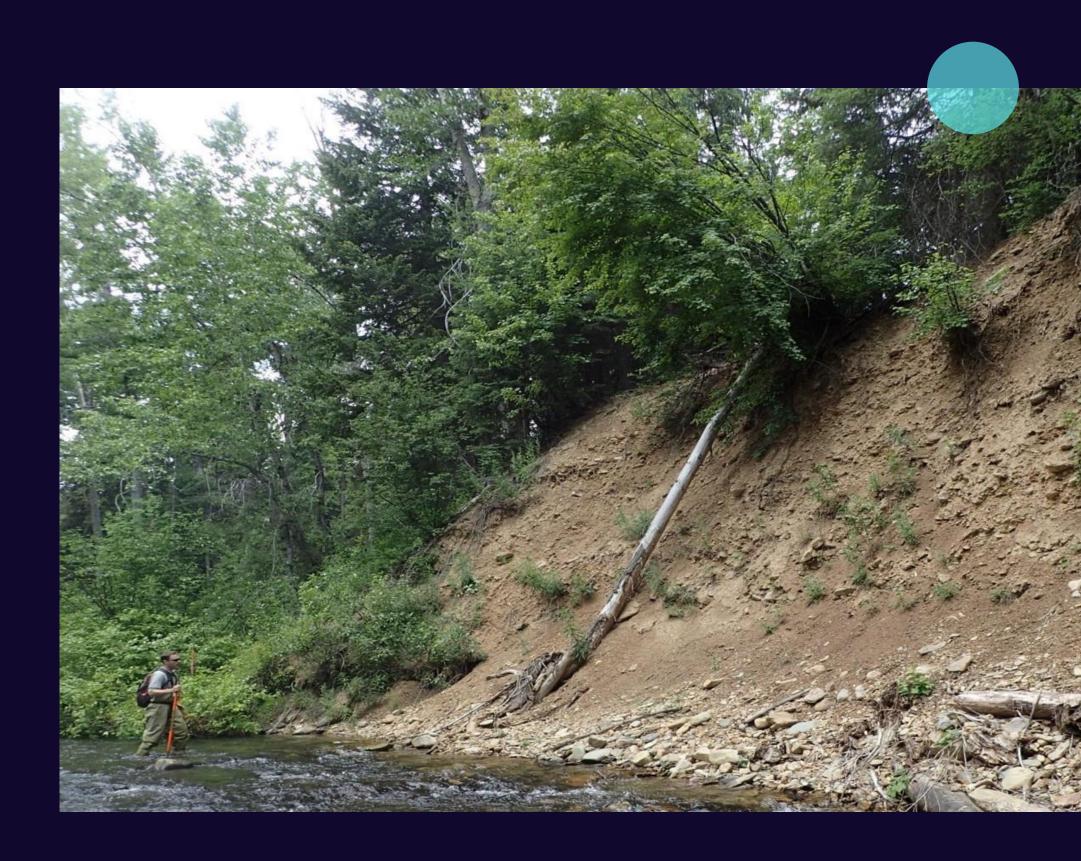
## FLOODPLAIN RESTORATION

# Heavily impacted by historical placer mining

- Channelized
- Disconnected floodplain
- High eroding banks
- High peak runoff

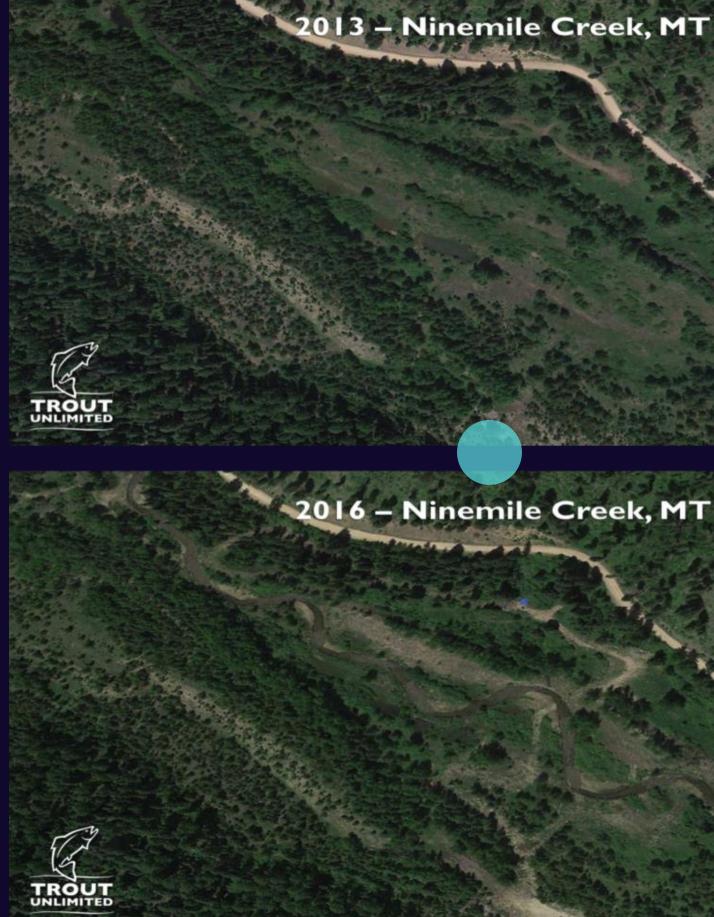
## FLOODPLAIN RESTORATION

#### Restoration

- Remove tailings piles
- Restore stream geometry
- Restore riparian habitat
- Create wetland habitat

#### Phases

- 5 complete
- 6th in progress
- Spaced out to minimize disturbance in watershed
- Highly specialized crew needed

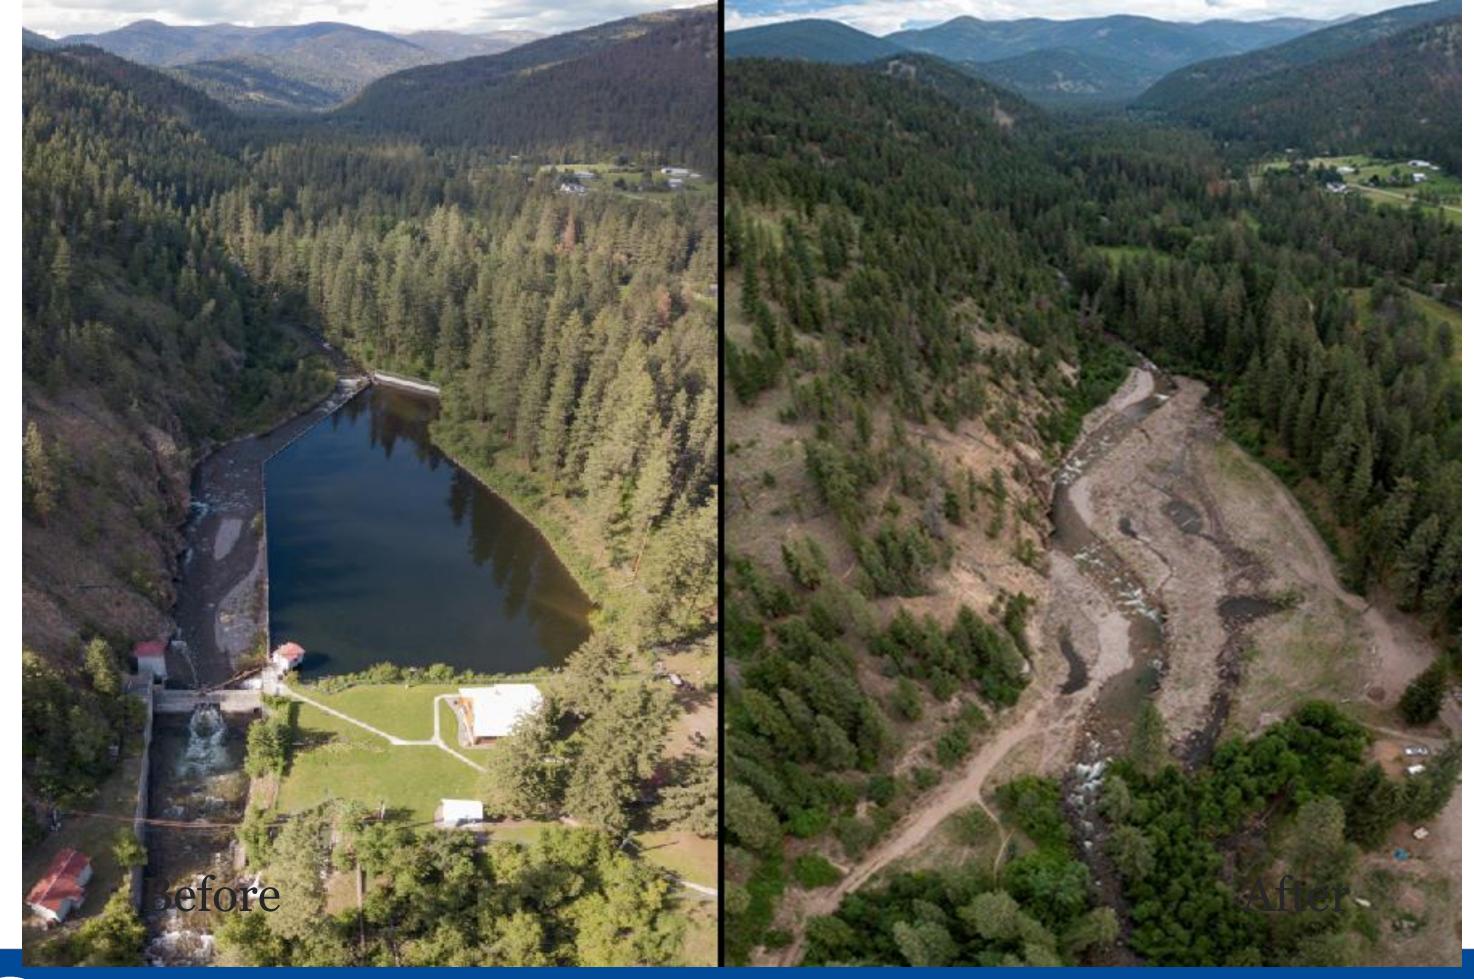
# **Flow on Rattlesnake Creek**

The historical drinking water supply for the city of Missoula came from the Rattlesnake Dam. The dam was considered inoperable after Giardia was discovered in the reservoir and the city switched to a groundwater aquifer. The dam was the source of the aquatic life impairment due to flow regime modifications.

#### Restoration

- Remove all infrastructure
- Restore approximately 1,200 feet of stream channel
- Add in natural floodplain features and wetlands

#### **Results**

- Increase floodplain function and water storage
- Mitigate flooding hazard
- Reconnect 26 miles of stream
- Add recreational opportunities
- Will move out of Category 4C
