# Draft Stream Relocation/Mitigation Guidelines

## KY Division of Water, December 2002 (Updated 10-15-07)

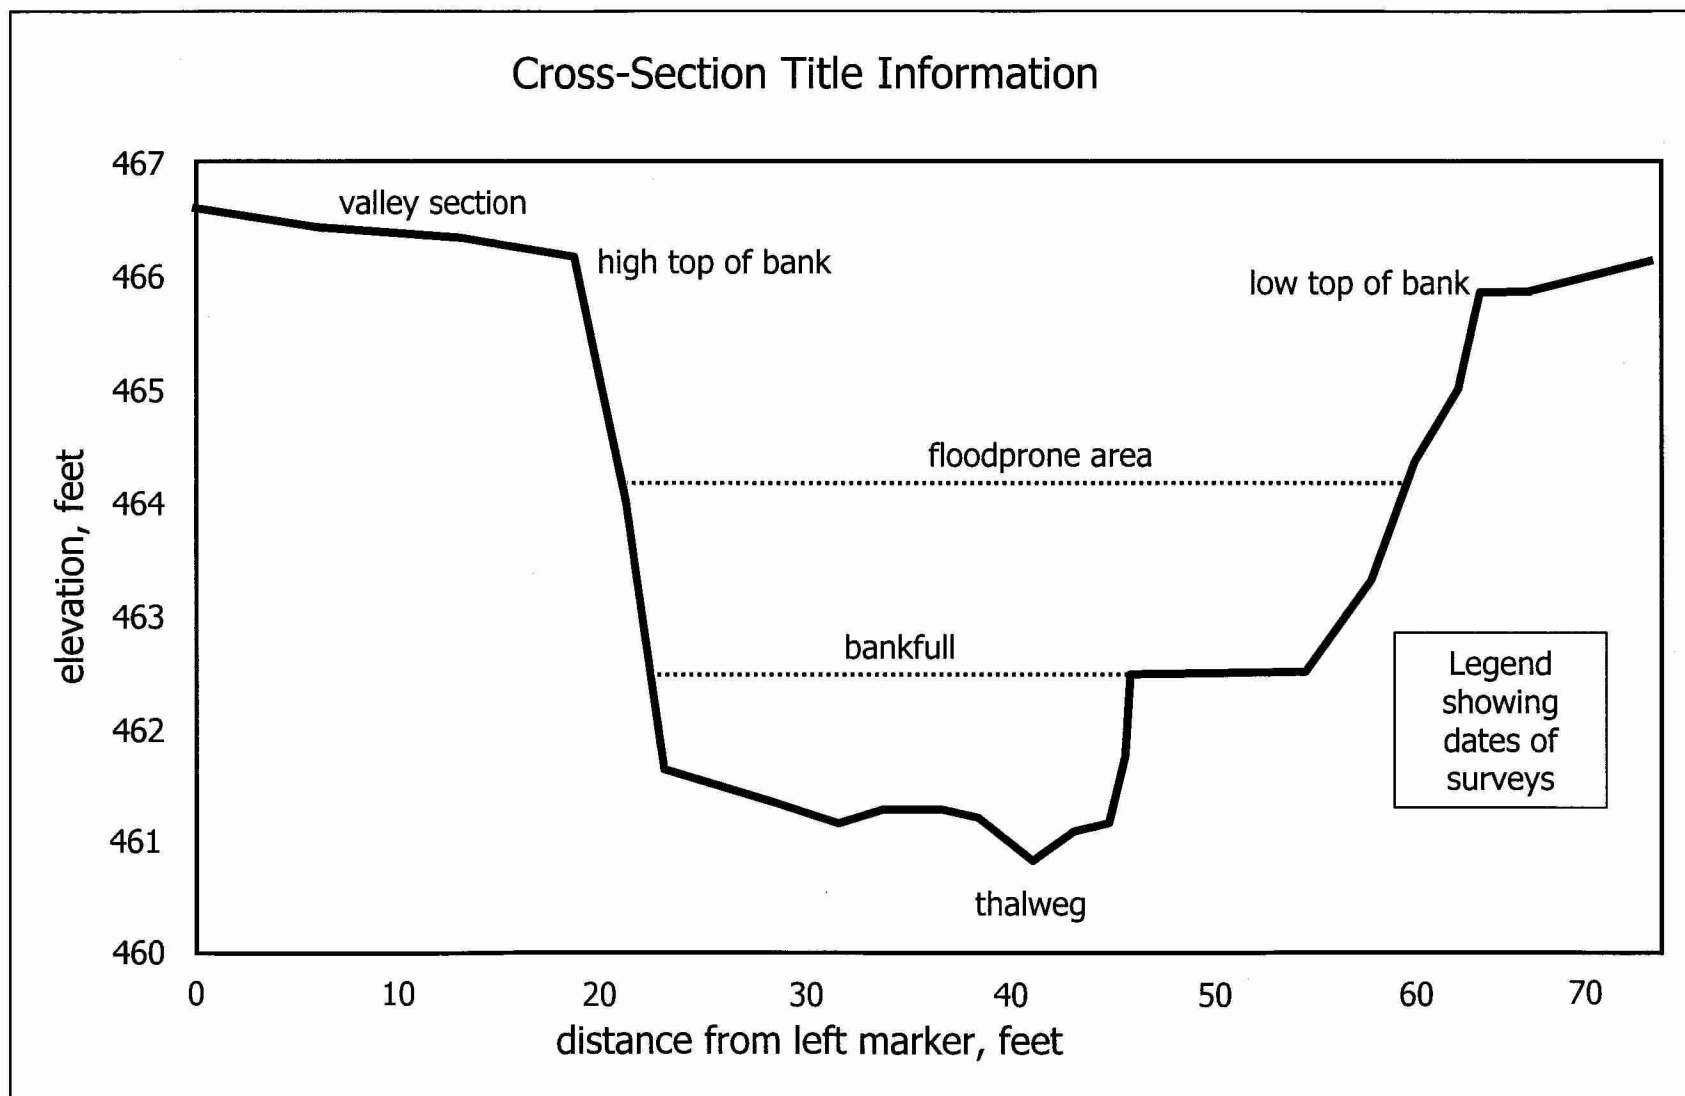
## Typical Channel Cross-Section

- Cross-sections must include the following: a minimum of 20 channel ground elevations, and sufficient ground elevations to describe the valley section, bankfull elevation, thalweg, top of bank, and any other important feature in the cross-section. Information shown in Attachment 3 is required, at a minimum. Concrete

- Cross-sectional Information: channel width and depth (riffles and pools); bankfull discharge area ( $A_{bkt}$ ), width ( $W_{bkt}$ ), and elevation; wetted perimeter ( $WP$ ); entrenchment ratio ( $ER$ ); hydraulic radius ( $R$ ); and floodprone width ( $W_{fp}$ ) and area ( $A_{fp}$ ). These features (except  $R$ ,  $ER$ ) must be shown on the typical cross-sections. Cross-sections must be taken for bend areas and straight reaches. Typical cross-sections must be provided for the reference stream segment as well as the post-construction channel. See Section 4 for appropriate procedures and Attachment 3 for an example.

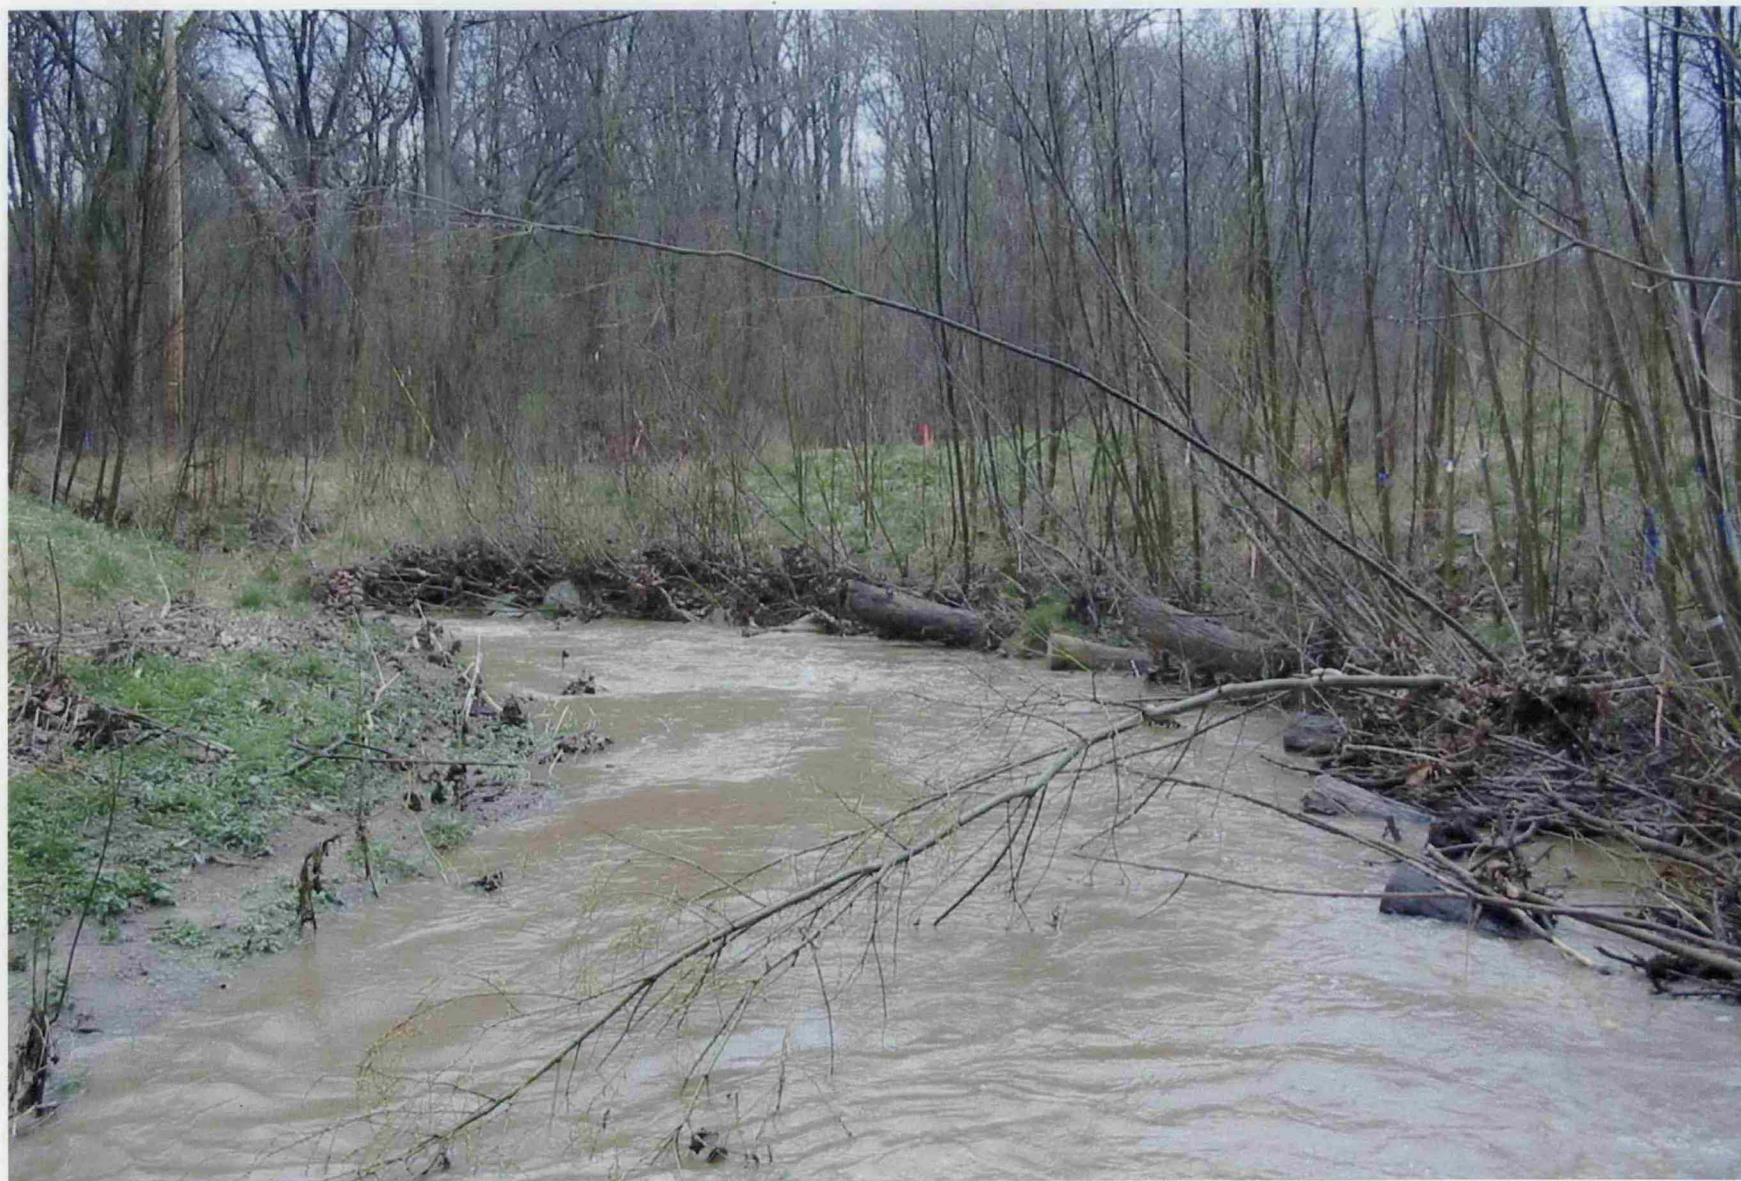
ATTACHMENT 5

2. **Permanent picture stations** must be established where pictures can be taken biannually (summer/winter). Photographic documentation of the success of the project is required with each monitoring report.
  - One station must be established downstream of each structure to provide an upstream view of the structure such that each large rock within the structure is visible.
  - One station must be established at each bend such that a downstream view of the downstream ½ of each bend is visible. See Attachment 5.
  - Photographs must also show riparian planting and erosion control measures.
